# TERWILLIGER FIRE

## SUPPRESSION REPAIR PLAN SEPTEMBER 11<sup>ST</sup>, 2018

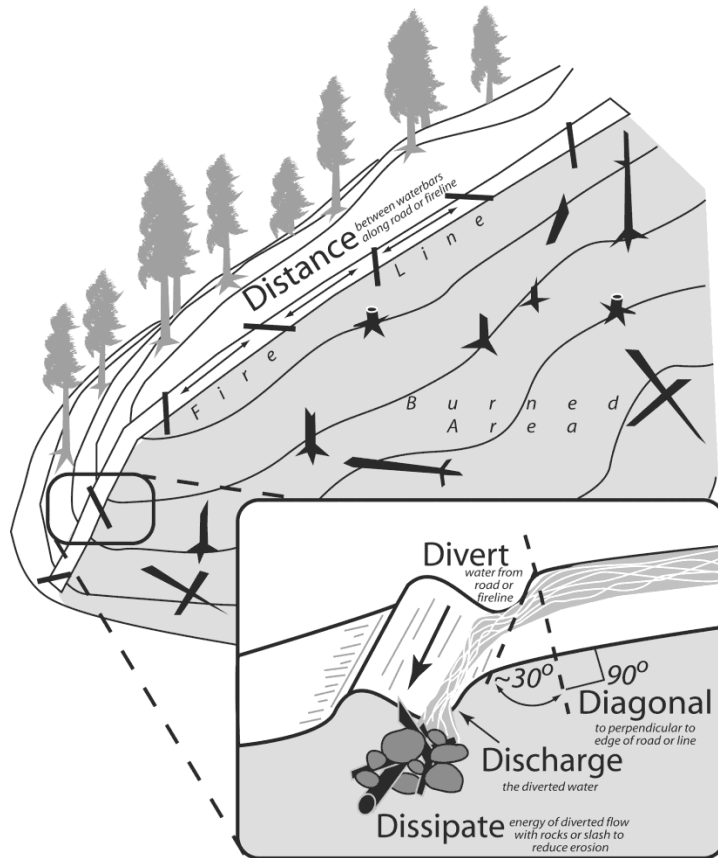
- On Hand line that is heavily compacted where subsoiling has proved ineffective, place waterbars according to the following guidelines:
  - 1) Dig/Excavate in the waterbar – do not simply push up loose soil.

- 2) Waterbars should direct runoff AWAY FROM the burned area where possible.
  - 3) Assure that the down slope end of the waterbar is open and has adequate length to allow free flow of water off the fire line.

- 4) Logs can be incorporated into waterbars as long as they are embedded or anchored in a trench
  - 5) Place slash below outlets of waterbars in steep areas or areas that outlet flow may cause erosion. This will help slow runoff and help collect sediment.

Fire Line Slope %	Maximum Water Bar Spacing (feet)
2-5	300
6-10	200
11-15	150
16-20	100
21-35	75
36+	50
